Superfund At Work

Northwest Transformer Mission/Pole Site Profile

Electrical Transformers Removed From Farming Community

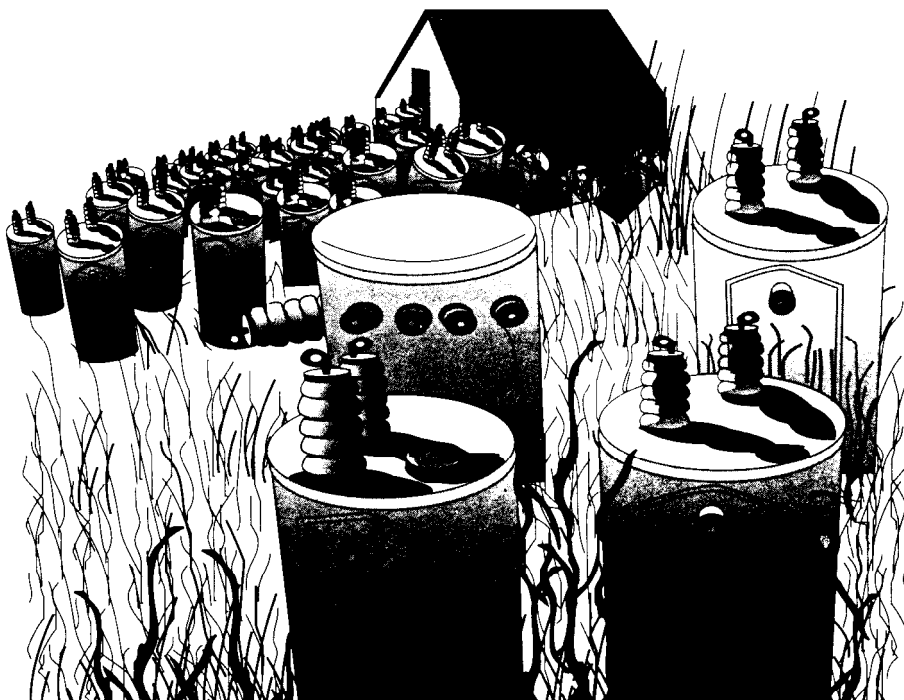
Hundreds of leaking transformers surrounded the wooden salvage barn.

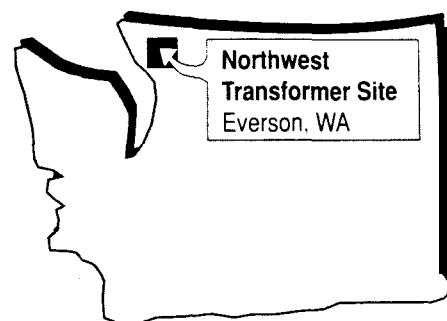
Hundreds of transformers littered the site
